The Trumpeter Swan Society

Centennial Valley Project

October 2011

Centennial Valley TrumpeterSwan Territory Assessments

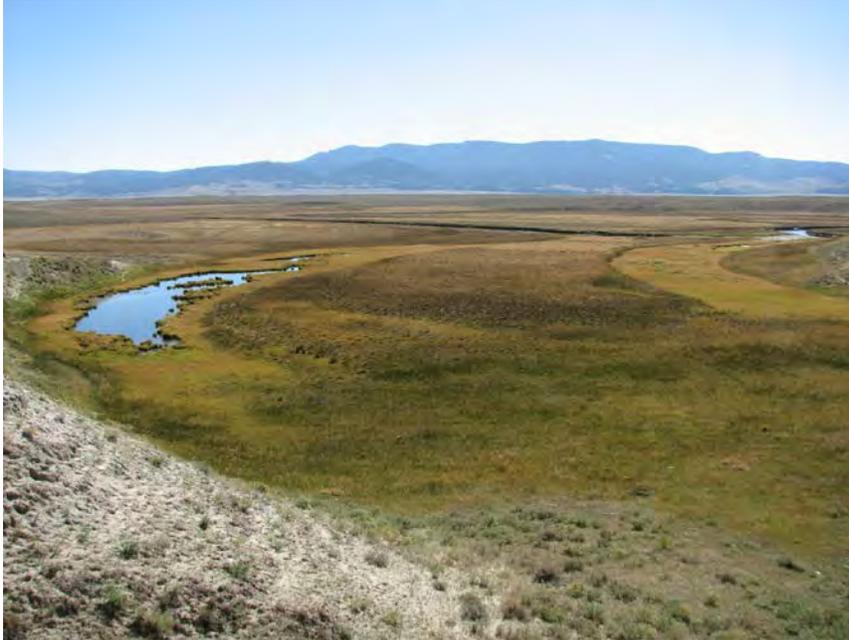
Figure 2. Hack Tower (riverine) territory where sedges have encroached throughout most of the isolated oxbow channels, significantly reducing open water availability.

2. Initiate a habitat enhancement program to restore open water habitat in isolated oxbows along the Red Rock River. Focus on the J Bar L Ranch alone would enhance habitat conditions on seven Trumpeter Swan territories.

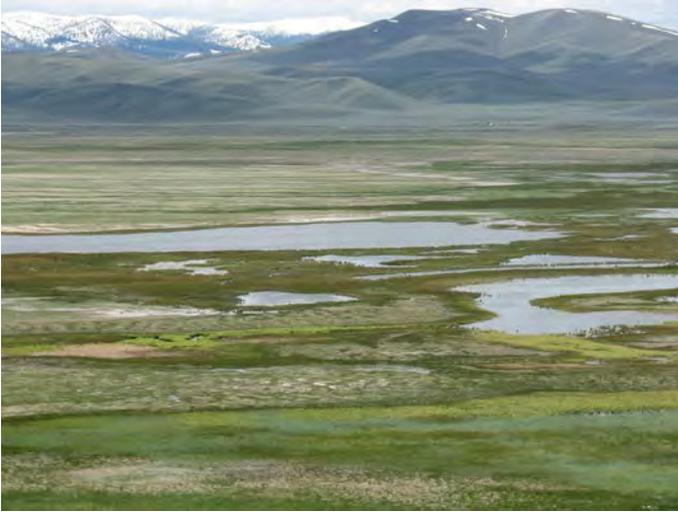
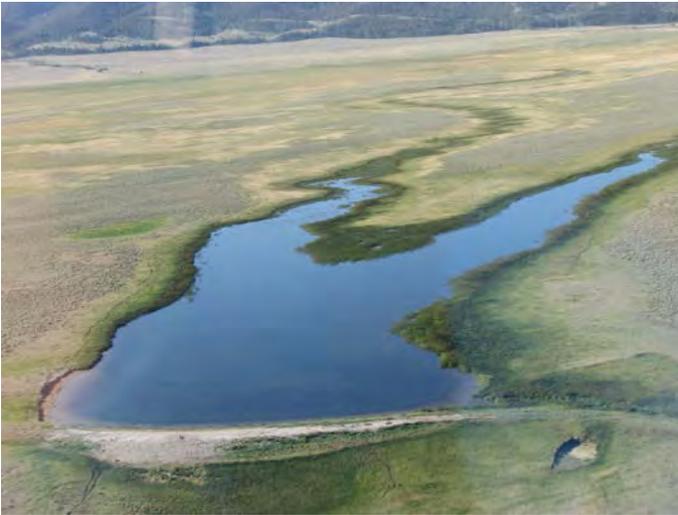
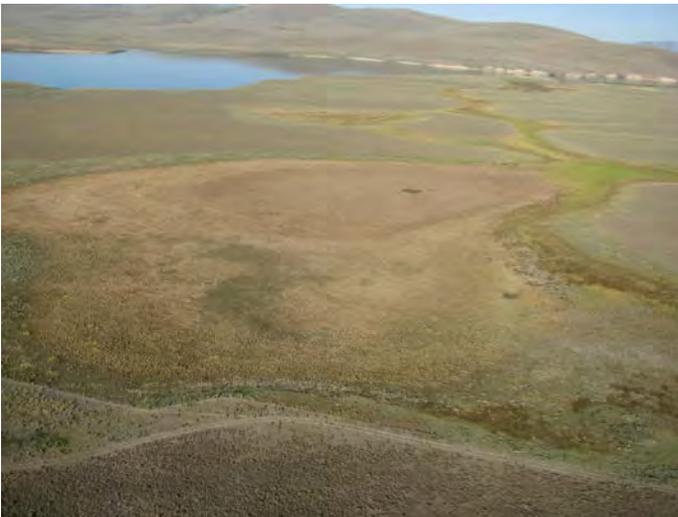
Figure 3. Upland pond/wetland habitats – wetland complex (top), drainage impoundment (middle), dry depressional wetland (bottom).

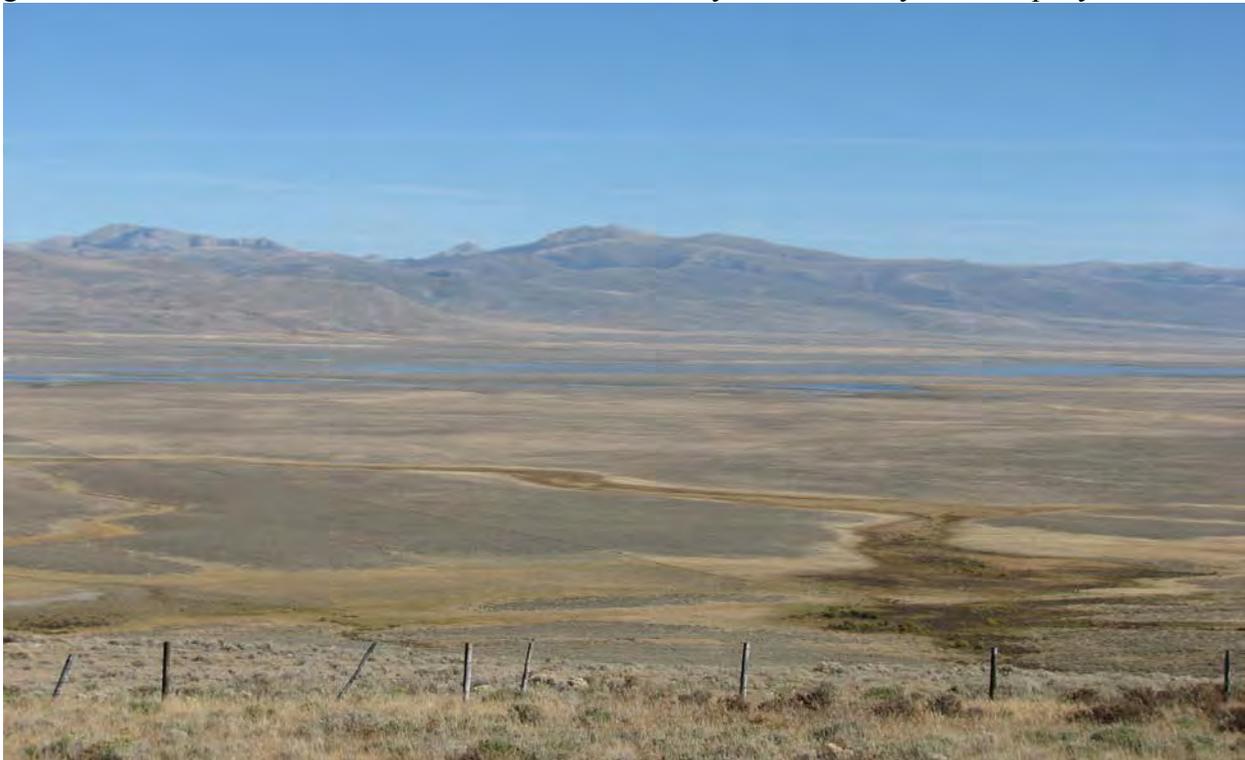
Figure 4. Lima Reservoir, Centennial Valley.

Lima Reservoir occupies the lower floodplain of the Red Rock River appearing as a long narrow lake with an irregular shoreline and several large bays at the mouth of tributary drainages (Figure 4). The reservoir is approximately 12 miles long and up to one mile wide with approximately 40 miles of shoreline at normal pool of which about 80% is public land. Due to the relatively flat terrain adjacent to the lake, the amount of actual water surface area varies significantly with water level, averaging about 5500 surface acres. The reservoir is relatively shallow, averaging perhaps 30-40 feet in the lower half and only 10-20 feet in the upper pool. The uppermost area is only 3-4 feet deep at full pool, and as water levels decrease, disproportionately large areas of lake bottom are exposed. The depth of the reservoir has been reduced significantly by

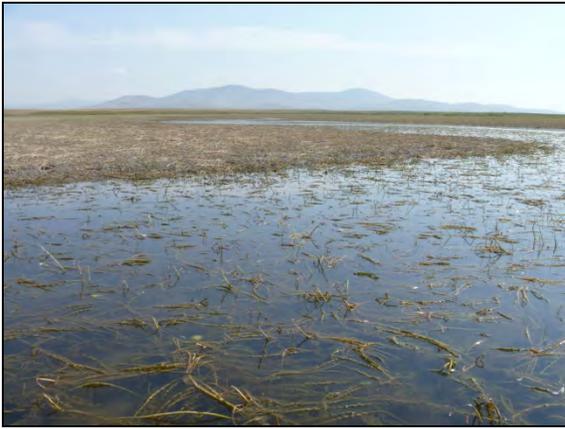
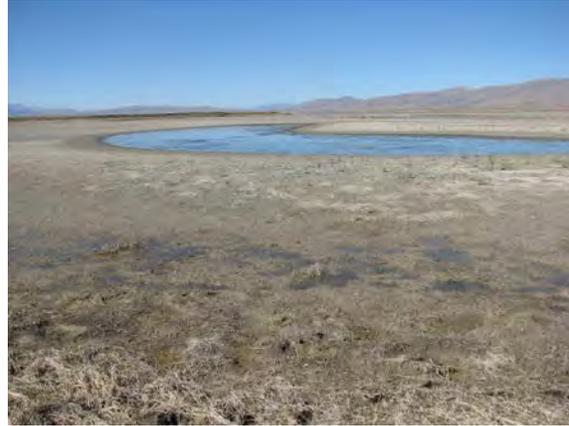
The eastern part of Lima Reservoir was dominated by *Hippuris vulgaris* (mare's tail). Discharges from the reservoir resulted in extensive flats of dry, saturated, and shallowly flooded (water depth ≤ 12 in [30 cm]) mare's tail habitats (Figure 5). Almost all the *H. vulgaris* observed in the reservoir had senesced. Stands of flooded mare's tail were generally monotypic with few other species of vegetation observed. Invertebrates observed within mare's tail communities include scuds, chironomids, side swimmers, and orb snails. *Potamogeton richardsonii* (Richardson's pondweed) was also common and abundant in deeper portions of the reservoir (observed water depths 3-7 ft [0.9 – 2.1 m]) often associated with the inundated river channel. Invertebrates observed were similar to those observed in mare's tail habitats. Other species of submerged aquatic vegetation observed within and adjacent to beds of Richardson's pondweed include *Myriophyllum exalbescens* (northern water milfoil), *Callitriche hermaphroditica* (autumnal water-starwort), and *Elodea canadensis* (Canadian waterweed). Stands of what is assumed to be *Elodea nuttallii* (Nuttall's waterweed) were observed in the western portion of the area surveyed that is more persistently inundated. Uprooted shoots of *Alisma* sp. (water pliantain) were also observed in beds of *P. richardsonii*.

Figure 5. Extensive beds of dry and shallowly flooded *Hipparis vulgaris* (mare's tail) at Lima Reservoir in early August (left, photo Adonia Henry) and 15 days after being exposed (right).

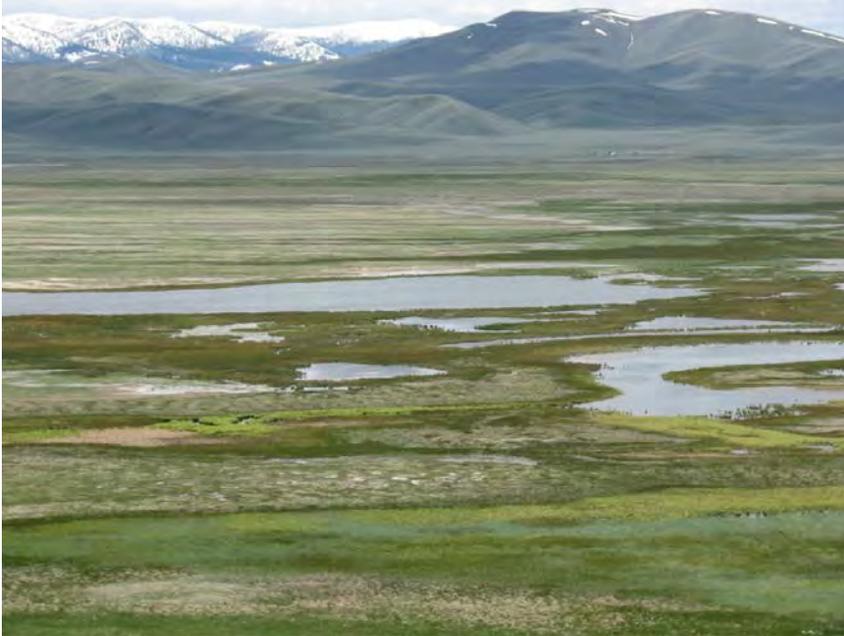
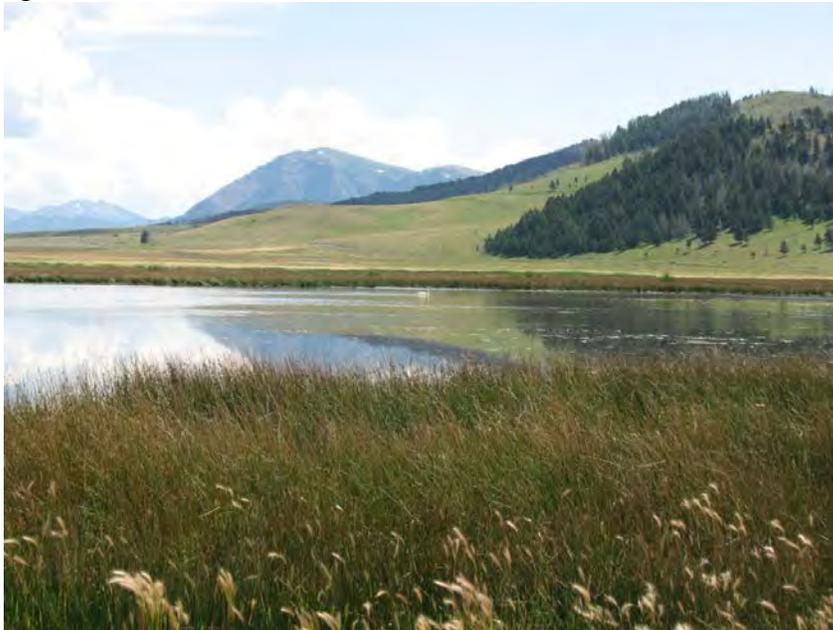
7L West, May 23, 2011

hazard. Seasonal livestock grazing can encroach on wetland area particularly on the west side and has reduced tall shoreline vegetation.

Management needs/opportunities: Irrigation diversion from Doyle Creek influences seasonal water levels, but return flows augment ground water to sustain wetland function. Upgrading diversion structures could improve water availability. Fence removal and relocation could reduce collision hazard. Interpretive services and swan viewing opportunities could be developed on public lands adjoining the county road.

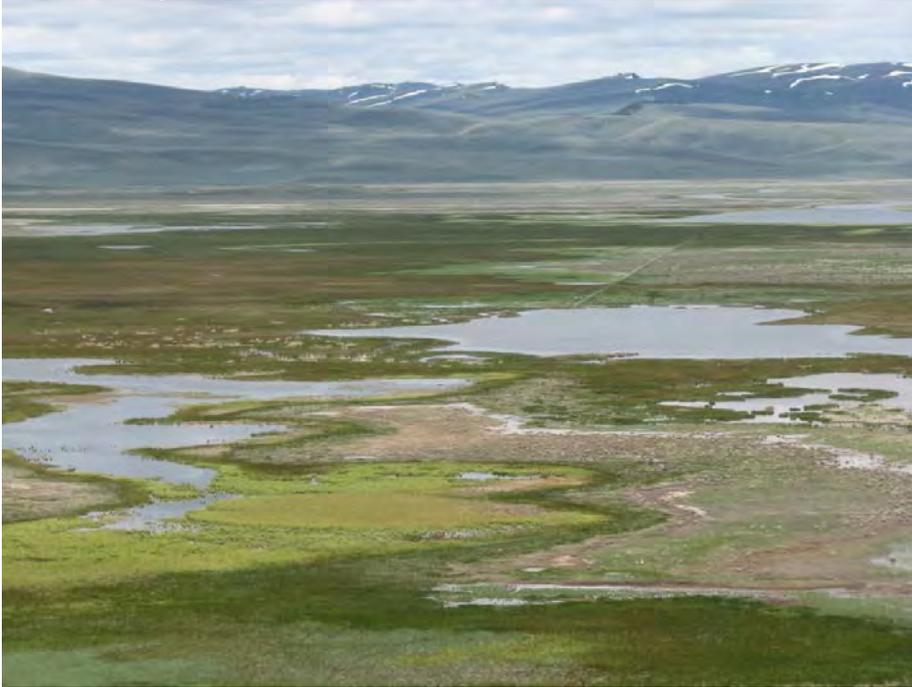
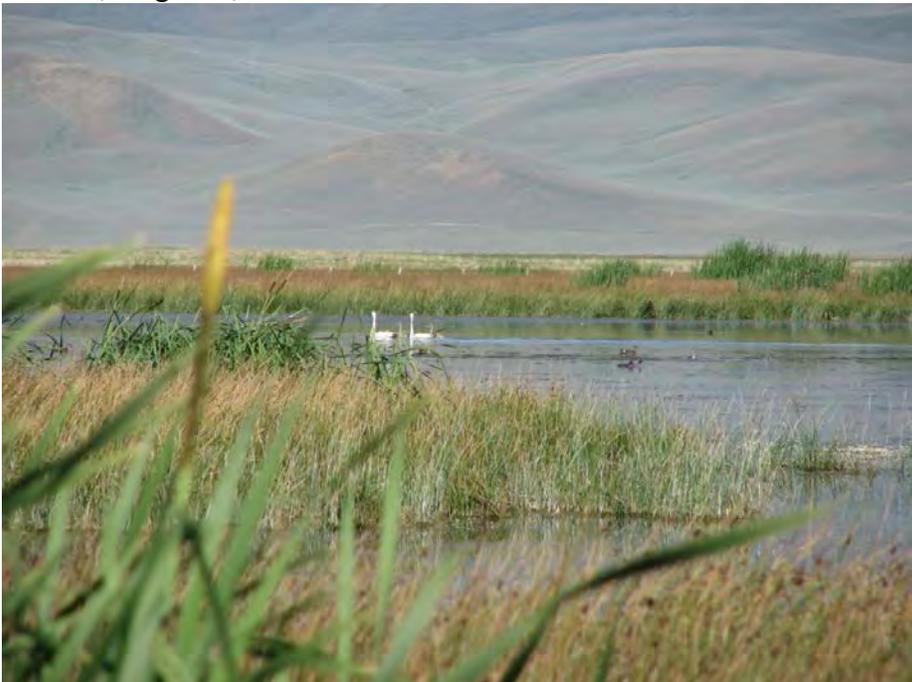
7L East, May 23, 2011

Disturbance/conflicts: Fences bisect the west pond and bond the north side of the wetland complex, and represent a potential collision hazard. Seasonal livestock grazing can encroach on wetland area particularly during low water years.

Management needs/opportunities: Irrigation diversion from Doyle Creek influences seasonal water levels, but return flows augment ground water to sustain wetland function. Upgrading diversion structures could improve water availability. Fence removal and relocation could reduce collision hazard. Interpretive services and swan viewing opportunities could be developed on public lands adjoining the county road.

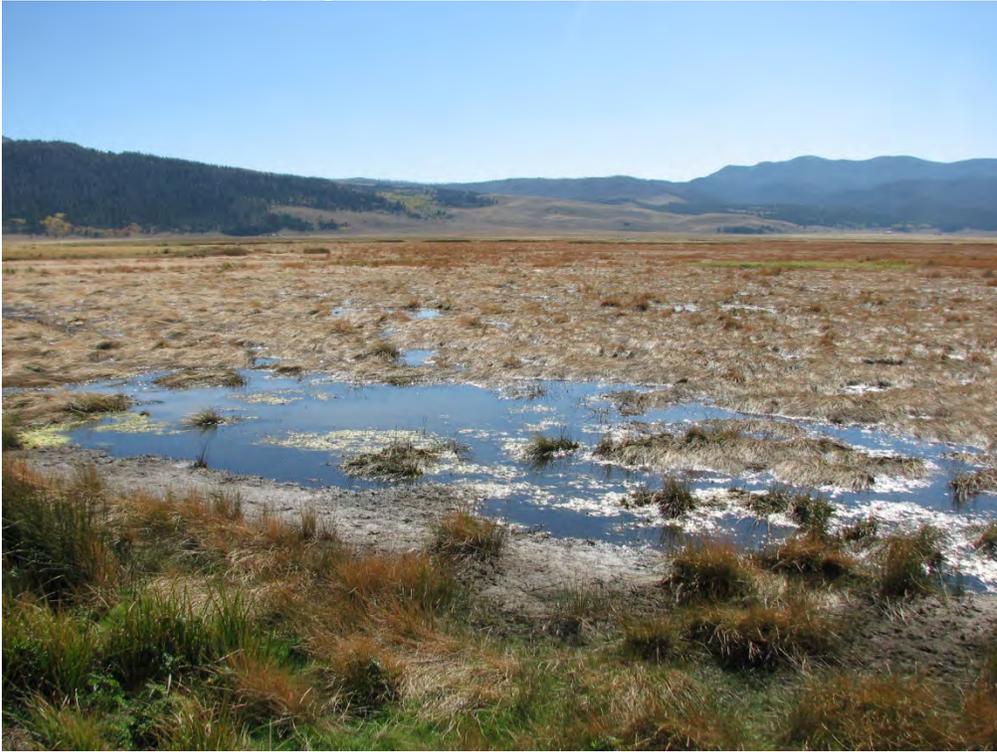
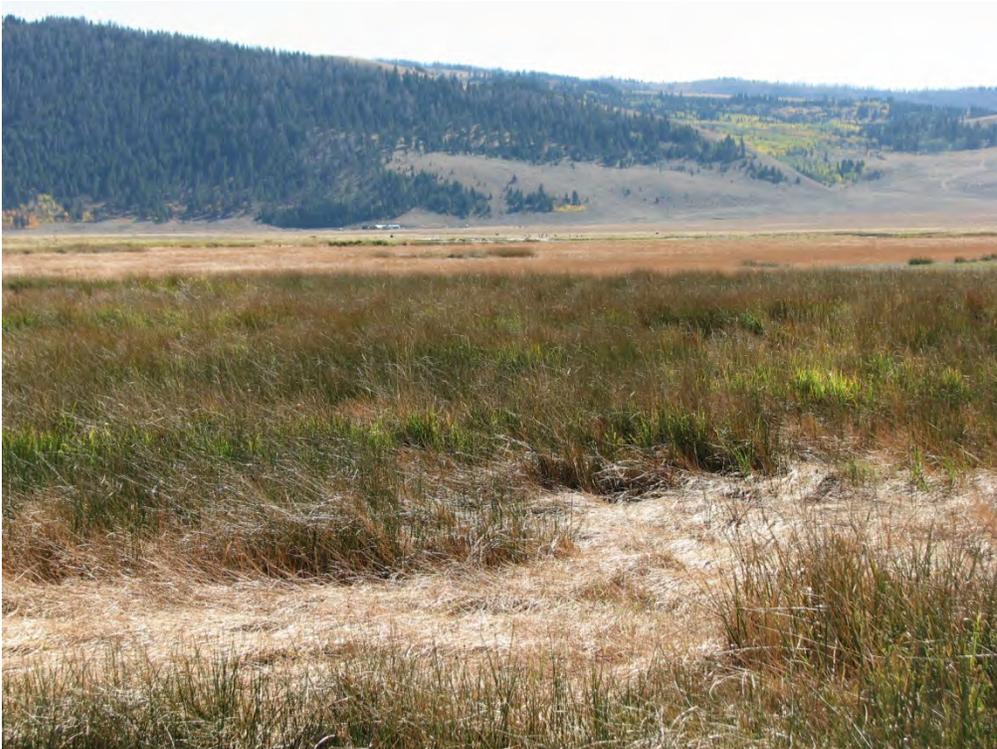
Schoolhouse territory, September 29, 2011

General site description: The Schoolhouse/Brundage Lane territory occupies a small, impounded wetland pond on a ditch system. The site is similar to many of the other depressional wetlands found in the valley. The dike and outlet for this system was upgraded in about 2008 through the USFWS Partners for Wildlife program and serves to enhance water storage capacity.

Nest site: None currently identified. No muskrat houses were observed despite being quite common on the adjacent 7L wetland.

Management needs/opportunities: Project agreement for dike/pond restoration ensures that this site will persist.

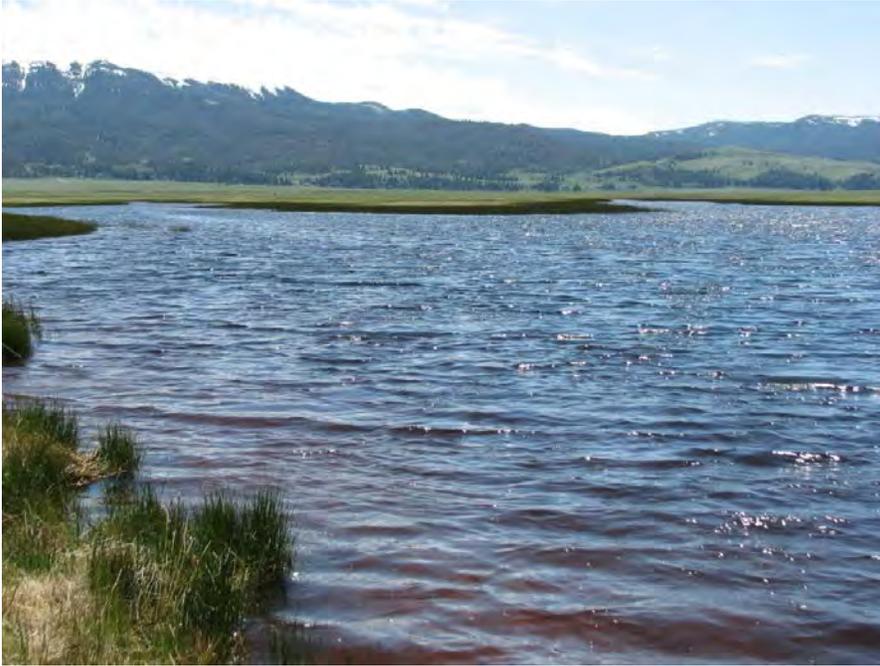
Bean Creek Reservoir, June 23, 2011

2011 Nesting Activity: Active, failed (livestock disturbance)

forks to limit cattle access to nest site.

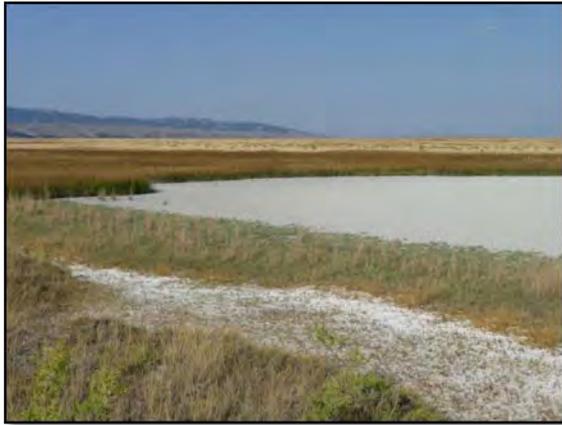
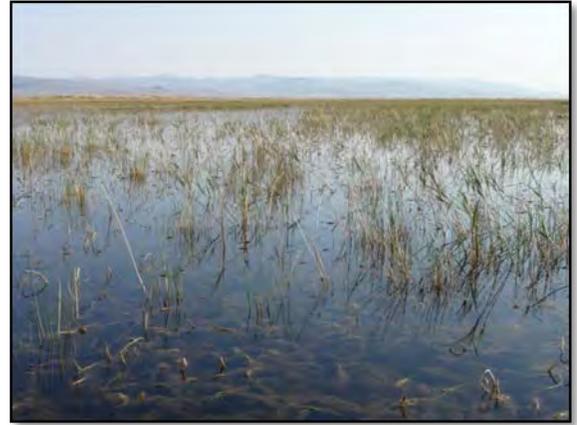
Diverse vegetation habitat types within the Passmore Wetland Complex during September 2011 (photos Adonia Henry).

Aquatic Vegetation: One of the saturated depressions within the wetland complex was ringed with *J. arcticus* on the south side and *D. spicata* on the north side. These species tolerate different salinities, suggesting that ground and surface water inputs are variable across a relatively short distance. Remnant submerged aquatic vegetation was observed on the underside of dried algal mats on dry and saturated mud flats. The transition zone between *J. arcticus* and *Eleocharis* sp. (robust spikerush) was drier than similar habitats at the 7L wetland. *Eleocharis* sp. was flooded up to 18 in (46 cm). *R. aquatilis* and *H. vulgaris* were present in some of the flooded *J. arcticus* and *Eleocharis* sp. zones. *R. flabellaris* (yellow water buttercup) was the dominant submerge aquatic species in one of open water depression surrounded by *Eleocharis* sp. Submerged aquatic vegetation in other open water habitats and sparsely vegetated areas of emergent vegetation (e.g., *Eleocharis* sp., *Carex* sp., and *J. arcticus*) included *H. vulgaris*, *R. aquatilis*, *S. pectinata*, *C. hermaphroditica*, and *U. vulgaris*. A pair of Trumpeter Swans was observed foraging in *Eleocharis* sp. flooded up to 2 ft (61 cm) where *S. pectinata* and *R. aquatilis* were the dominant submerged aquatic species. Aquatic invertebrates observed include water striders, dragon fly larvae, side swimmers, beetles, and orb snails.

Management needs/opportunities: In 2011, this pair and cygnets moved off the

Passmore Pond onto Jones Creek and the impoundment pond downstream possibly since Passmore became so heavily vegetated. Actions to maintain open water may be desirable.

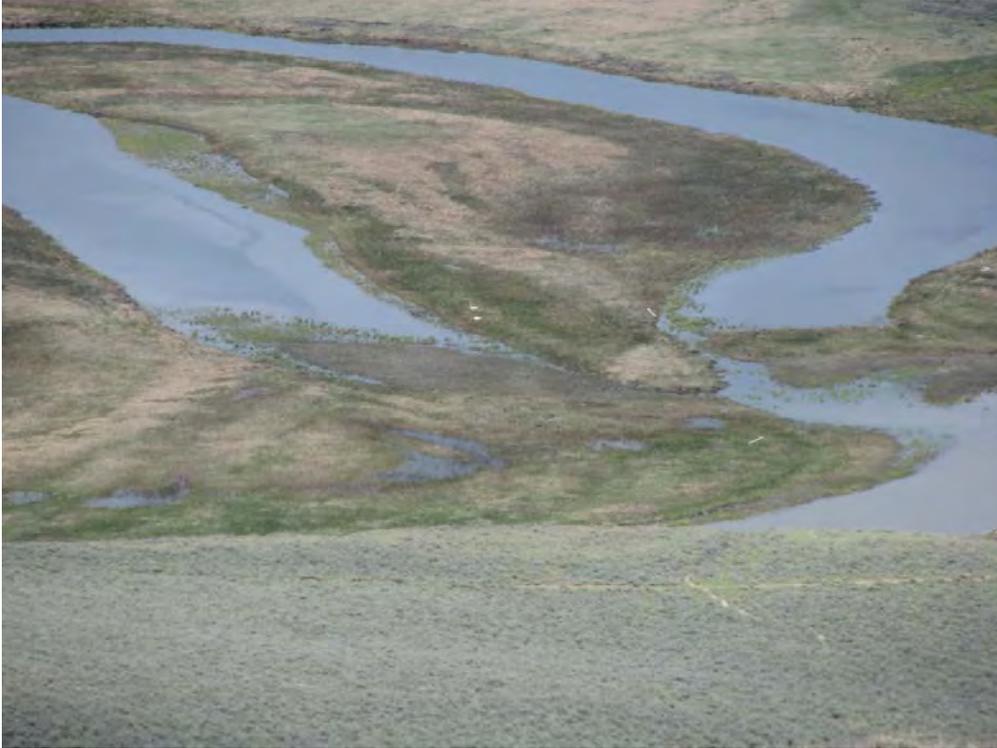
Disturbance/conflicts: High intensity livestock grazing could concentrate cattle on this set of oxbows and displace swans. A pasture division fence crossing the river at the lower end of the territory has caused collision mortality in the past.

Forsythe territory, breeding pair of swans on probable nest site, May 23, 2011

Management needs/opportunities: J Bar L is sensitive and supportive of swan conservation, and the close proximity of this territory to their headquarters buildings is an attraction for their visitors. Fencing that could cause collision mortalities and temporary fencing that could prevent livestock concentrations on the territory need to be discussed.

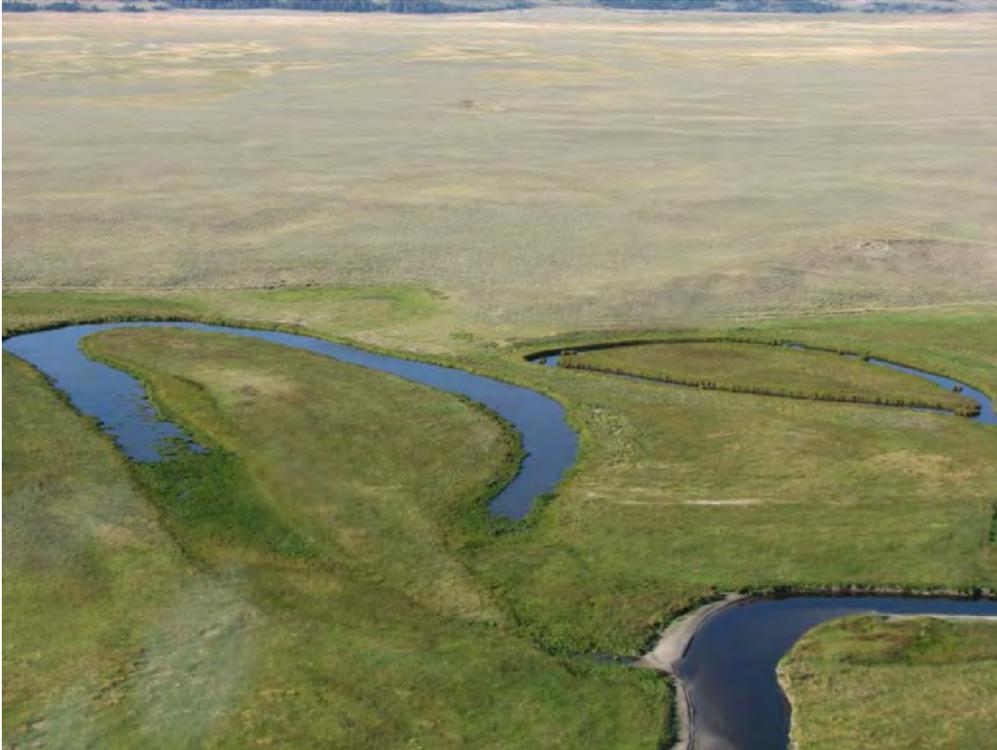
Forsythe territory, oxbow on right was excavated in 2007. August 19, 2011

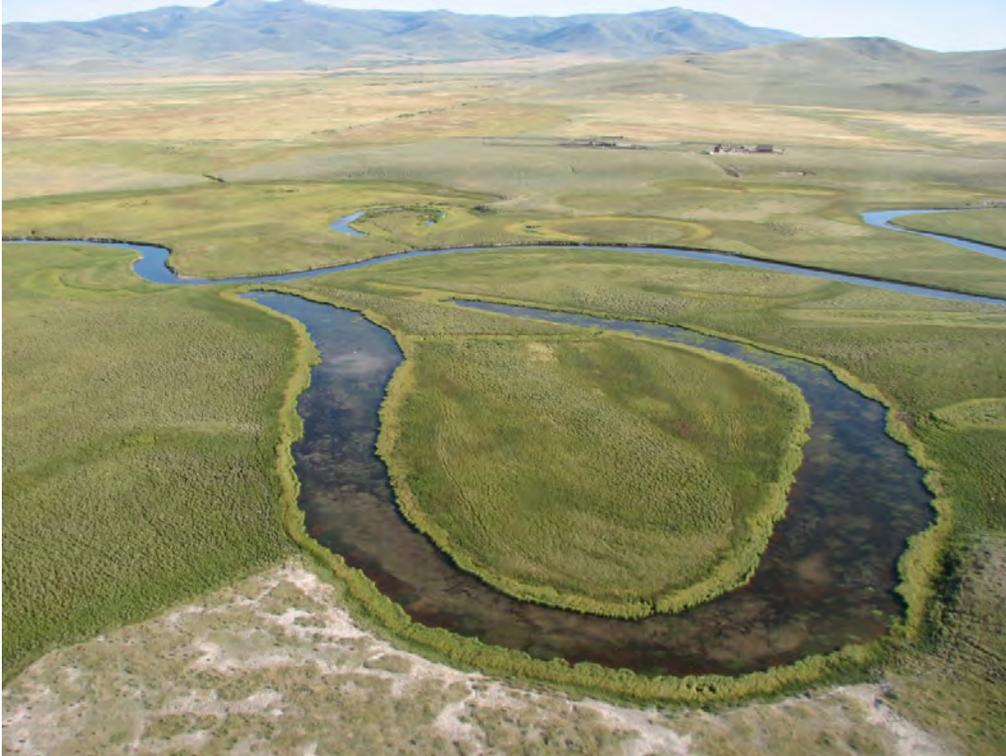
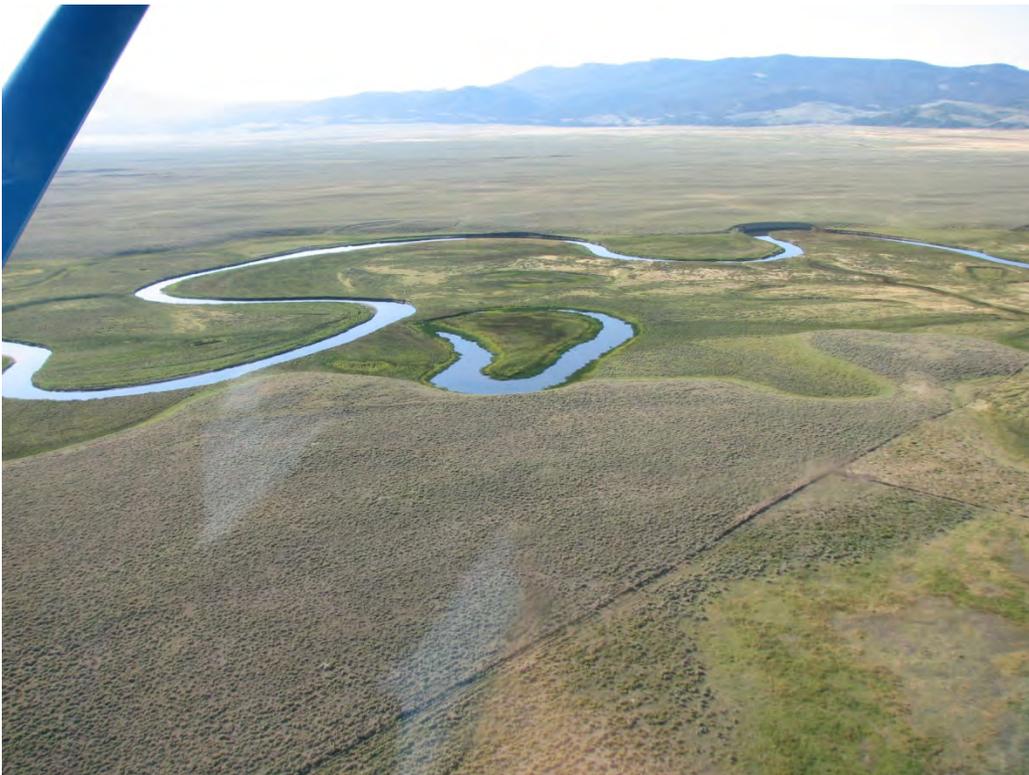
Duffner territory, August 19, 2011

Emergent Vegetation: Abundant water sedge (*Carex aquatilis*), beaked sedge (*C. rostrata*), and Baltic rush (*Juncus balticus*) around fringe of oxbows. On some oxbows, this sedge vegetation is becoming dense enough to limit open water and suitable habitat for swan use. Small patches of cattail (*Typha latifolia*) are present on the large oxbow south of the river. Cattails have not occurred downstream of Brundage Lane until very recently.

become overgrown with emergent vegetation could be excavated to restore open water areas. Similar work in the adjoining Forsythe territory in 2007 enhanced swan use.

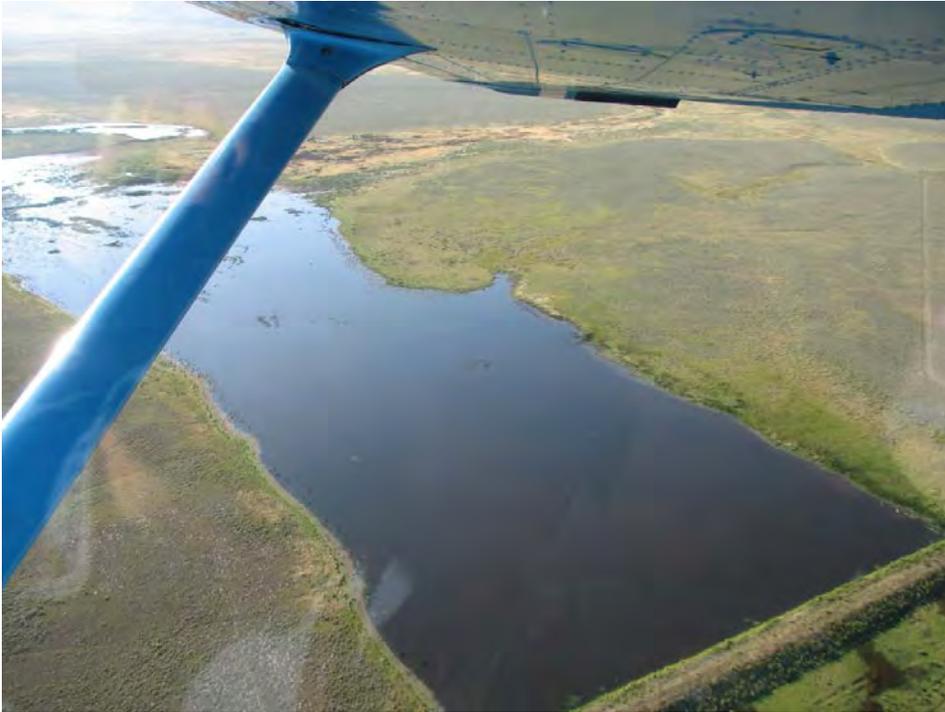
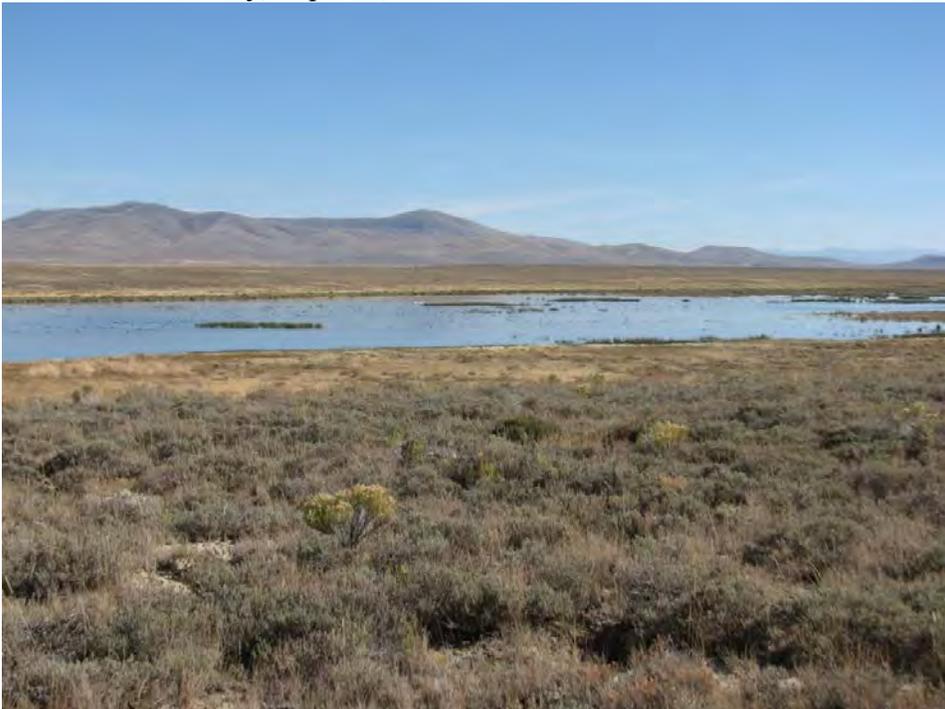
Sand Creek territory, August 19, 2011

General site description: The lower Sand Creek drainage is a large wet meadow area with two natural ponds and an intermittent stream channel. Potholes were blasted in this area in the 1980's to provide small open water areas in otherwise continuous vegetative cover (*Carex rostrata*). In 1987, BLM and Ducks Unlimited cooperatively constructed a dike on the lower end of this wetland area to impound up to 160 surface acres of water. Inflows to the area are inconsistent and have yet to completely fill the basin. A small pond has always been present at the dike, and since 2008 the pool has extended sufficiently to encompass the two natural ponds. Sand Creek DU and Mud Lake are the largest water bodies away from Lima Reservoir in the lower part of the Centennial Valley.

Emergent Vegetation: Tall rushes (*Juncus* spp.) dominate the larger of the two natural ponds with patches pioneering around the impounded pond. Beaked sedge (*Carex rostrata*) and spikerush (*Eleocharis* sp.) dominate the wetter portions of the surrounding wetland.

impoundment of all inflows annually at least through the end of August would significantly enhance further wetland development and Trumpeter Swan habitat. Planting of taller emergent vegetation could enhance cover values.

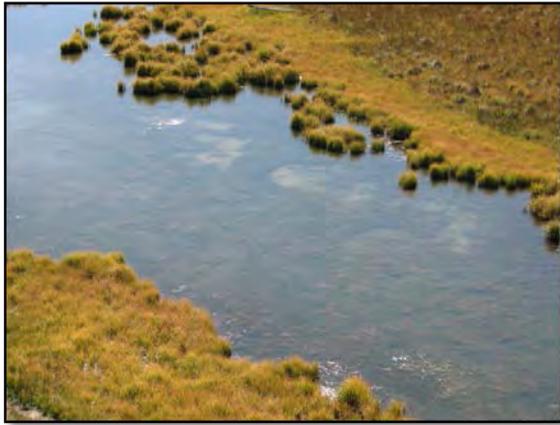
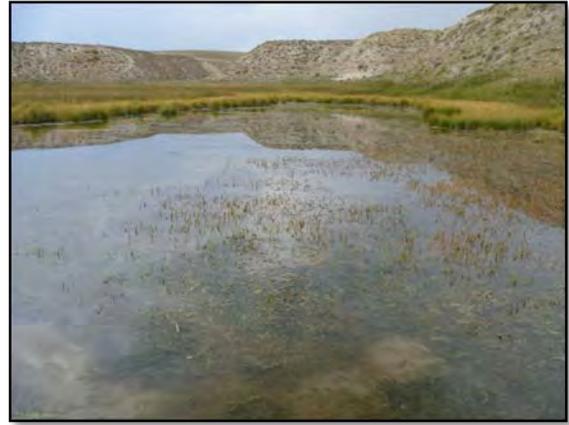
Aquatic Vegetation: *L. minor*, *Alisma* sp., and *Sagittaria* sp. were observed along edge where the open water/ submerged aquatic vegetation transitioned into robust emergent vegetation. *S. pectinata*, *E. canadensis*, and *P. richardsonii* had patchy distributions in the Red Rock River channel upstream and downstream of the Hack Tower territory.

Submerged aquatic vegetation habitat at the Hack Tower Oxbow, Red Rock River during September 2011(right photo Adonia Henry).

Management needs/opportunities: Timing of grazing treatments, herding activities and temporary fencing that could prevent or minimize livestock concentrations on the territory need to be discussed. Oxbow channels that had become overgrown with emergent vegetation on the upstream Forsythe territory were excavated to restore open water areas. Similar work in the Hack Tower territory would enhance swan use.

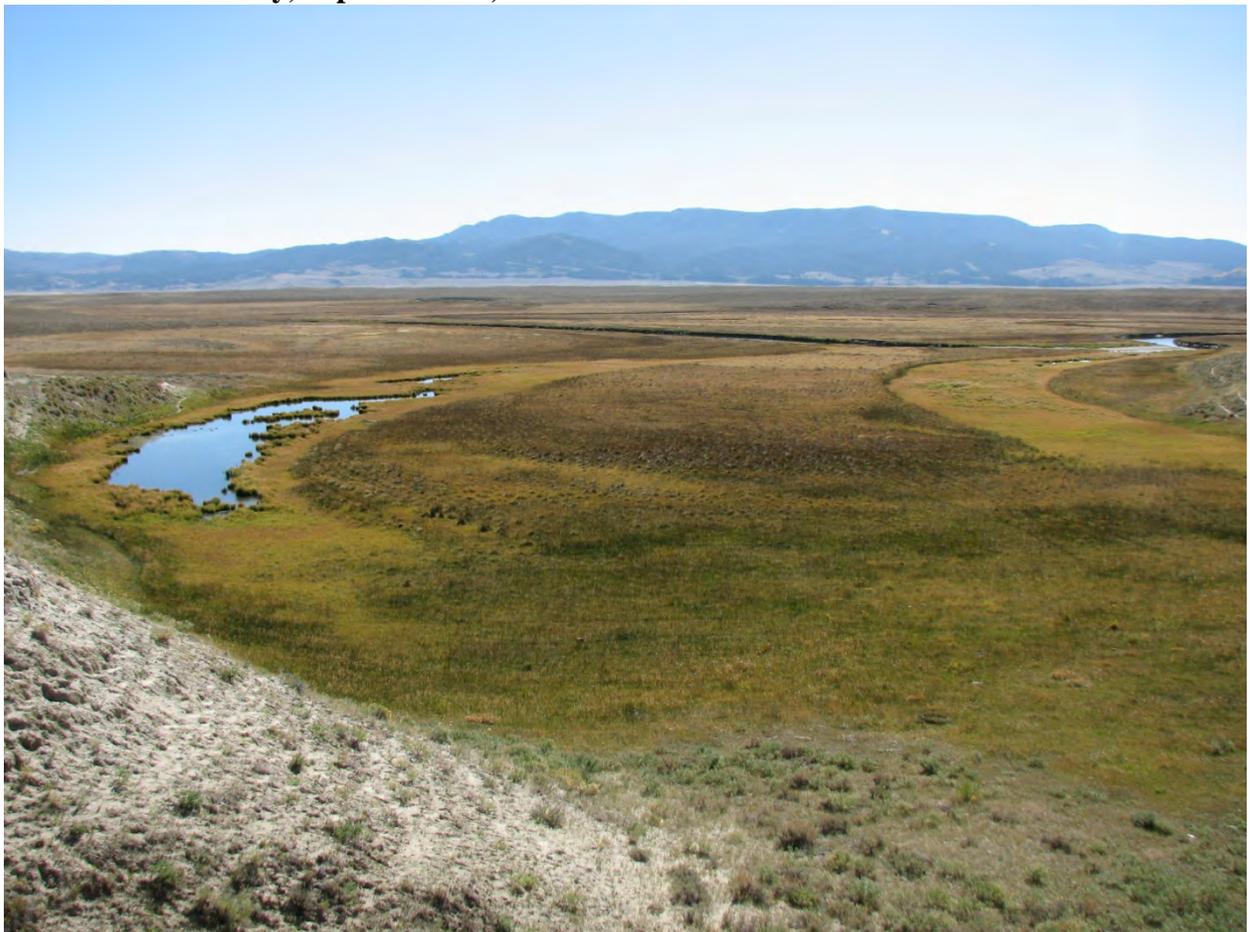
Hack tower territory, September 29, 2011

Emergent Vegetation: Beaked sedge (*Carex rostrata*) and water sedge (*C. aquatilis*) are becoming dense enough in oxbows to limit open water area and depth, and suitability as swan habitat. Baltic rush (*Juncus balticus*) bounds the fringes of oxbows.

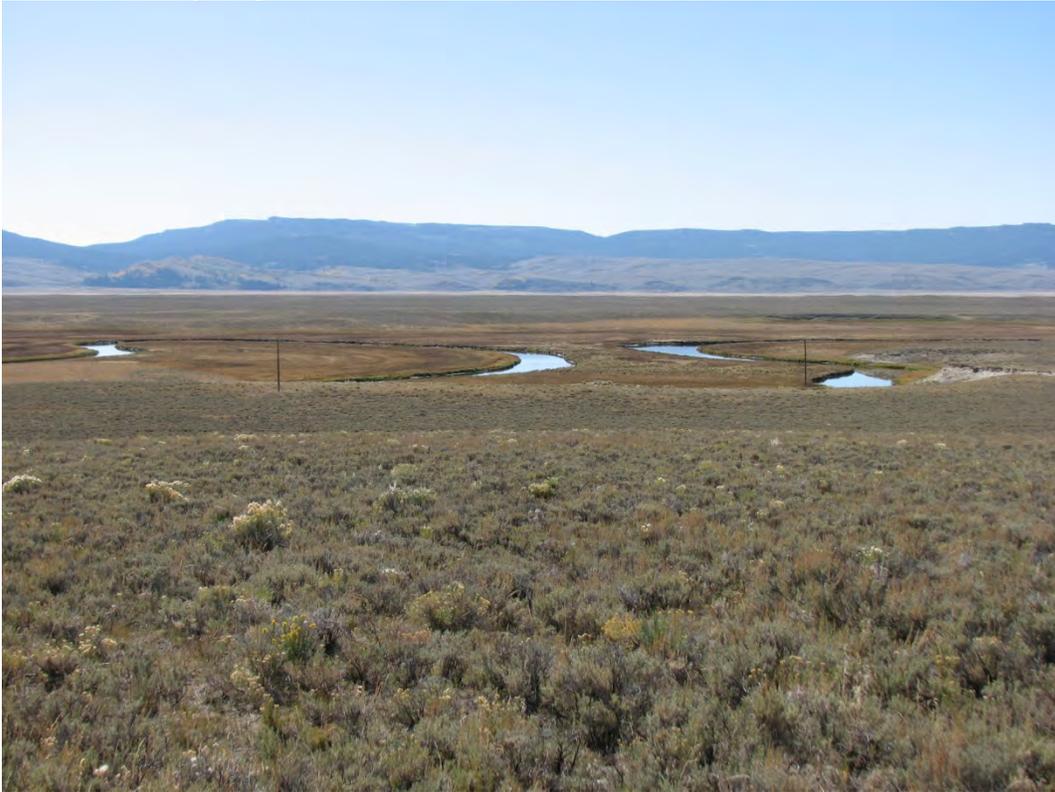
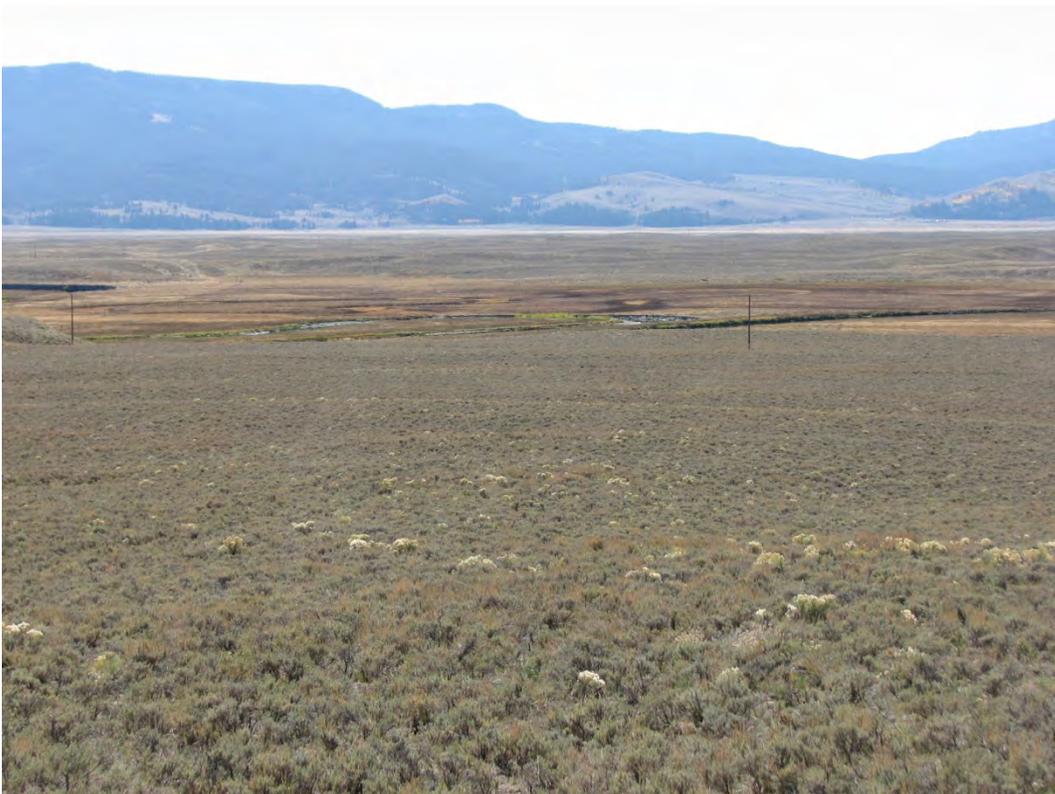
Oxbow territory, Sept. 29, 2011

Emergent Vegetation: Abundant water sedge (*Carex aquatilis*), beaked sedge (*C. rostrata*), and Baltic rush (*Juncus balticus*) around fringe of the largest oxbow. On most other oxbows, this sedge vegetation has become dense enough to limit open water and suitable habitat for swan use.

Management needs/opportunities: Timing of grazing treatments, herding activities and temporary fencing that could prevent or minimize livestock concentrations on the territory need to be discussed. The close proximity of this territory to J Bar L headquarters is an attraction for their employees and visitors. Oxbow channels that had become overgrown with emergent vegetation could be excavated to restore open water areas.

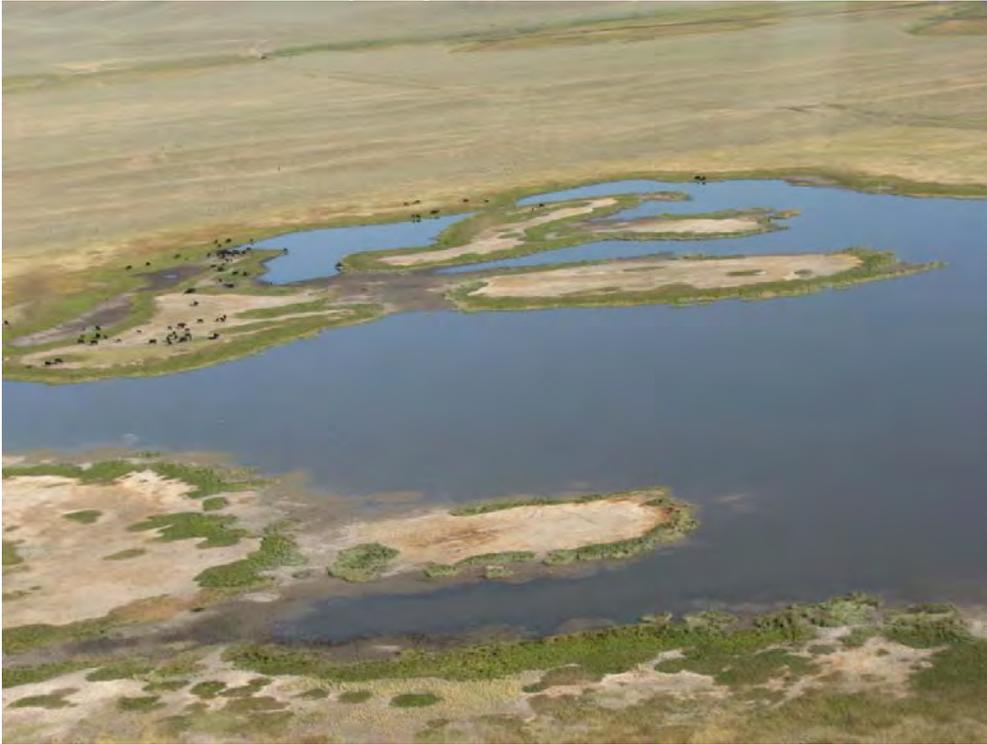
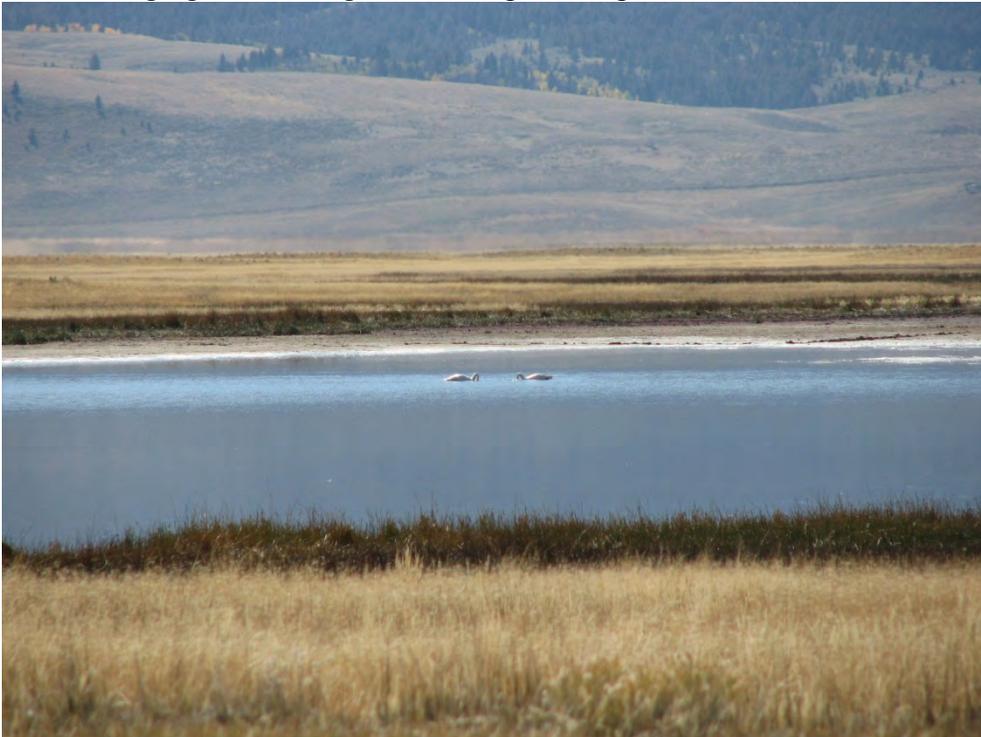
Brundage Sandhills territory, August 19, 2011

Swans foraging on Brundage Sandhills pond, Sept. 29, 2011

Management needs/opportunities: This territory has always attracted swans but production has not been clearly documented. Large numbers of swans have been seen on this pond during August but current vegetation abundance would not sustain that level of foraging. A pair of swans was observed foraging on this pond throughout the 2011 season. Monitoring aquatic vegetation production and use throughout the growing season may indicate higher potential than currently assumed. Controlling livestock utilization and/or planting taller emergent vegetation (*Typha* sp.) could enhance cover values.

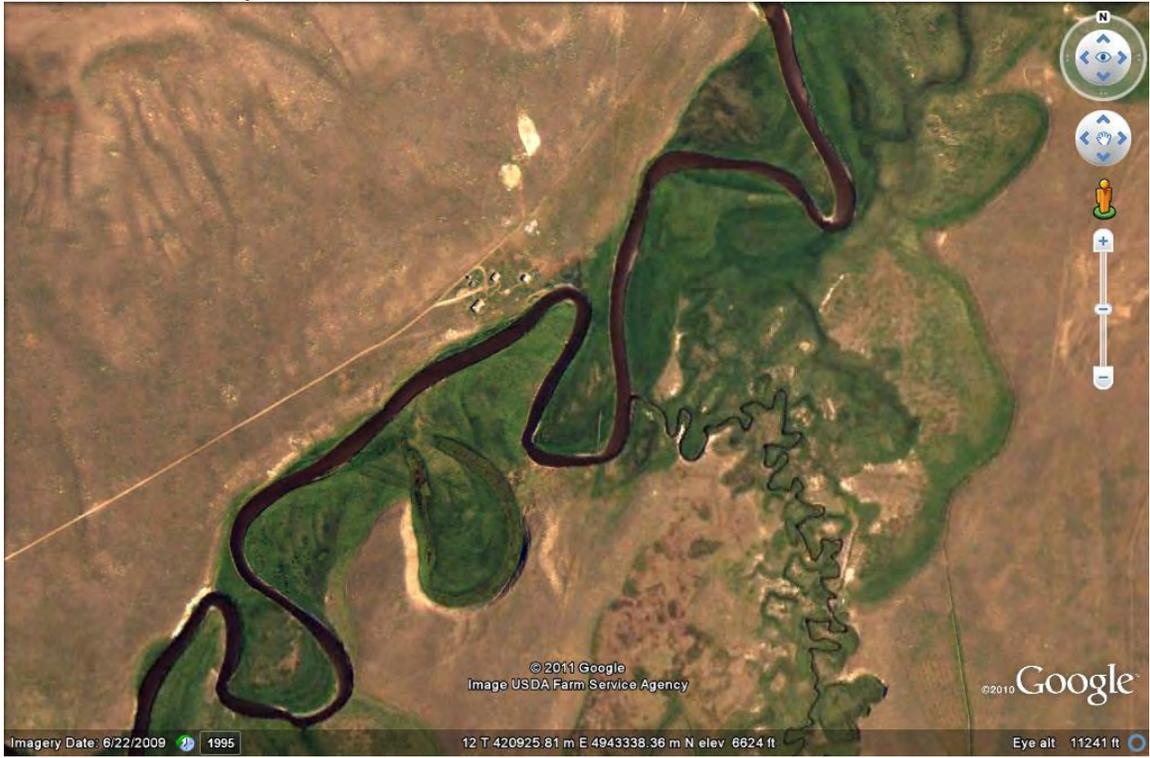
Emergent Vegetation: This site is becoming densely vegetated with water sedge (*Carex aquatilis*) and beaked sedge (*Carex rostrata*), and is limiting open water area. Baltic rush (*Juncus balticus*) dominates the fringe of oxbows and adjoining wet meadow areas.

Management needs/opportunities: J Bar L is sensitive and supportive of swan conservation, and occupancy of the Brundage cabins usually occurs after swan nests are already established. The close proximity of this territory to these cabins is an attraction for their guests and visitors. Electric fence could be located to exclude cattle from the immediate area of the oxbow to prevent displacement. Oxbow channels that had become overgrown with emergent vegetation on the adjoining Forsythe territory were excavated to restore open water areas. Similar work in the Mud Creek territory would enhance swan use.

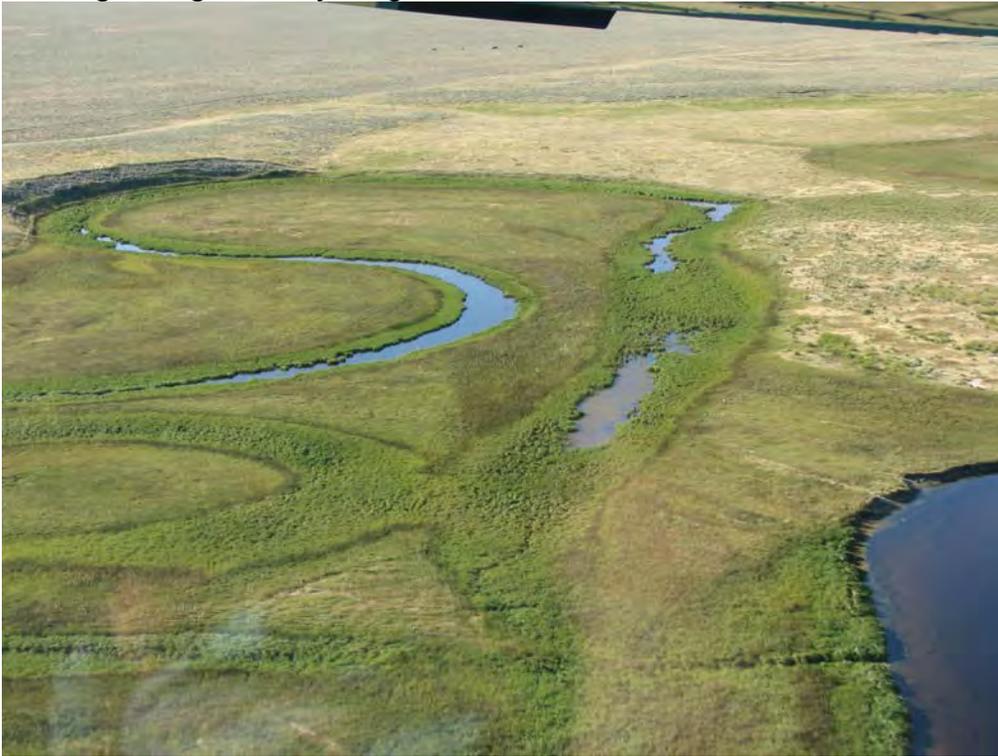
Brundage Bridge territory, August 19, 2011

Emergent Vegetation: Oxbows on this site have become densely vegetated with water sedge (*Carex aquatilis*) and beaked sedge (*Carex rostrata*) which is limiting open water area. Baltic rush (*Juncus balticus*) dominates the fringe of oxbows and adjoining wet meadow areas.

Management needs/opportunities: A portion of this territory wetland was recently acquired by BLM from J Bar L. J Bar L is sensitive and supportive of swan conservation. Timing of grazing treatments and locating temporary fencing that could prevent livestock concentrations on the territory need to be discussed. Oxbow channels that have become overgrown with emergent vegetation could be excavated to restore open water areas. Similar work in the Forsythe territory enhanced swan use.
